ICYNENE INC.

**Research Summary:
Field Performance of ocSPF-
Insulated Unvented Roof
Assemblies in the Climate of
Vancouver, British Columbia,
Canada**

Building Science Consulting Inc.
167 Lexington Court, Unit 5
Waterloo, Ontario
Canada N2J 4R9

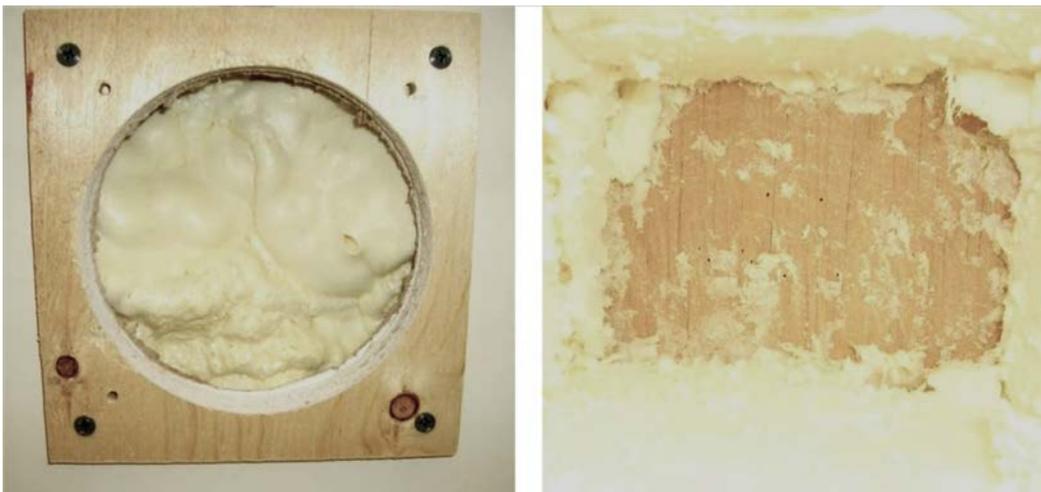
Figure 9 – Dunbar-Southland House – Jig and Core Through Drywall (left) and Foam Cut to Interior of Plywood (right)

For wood and wood-based materials such as plywood roof sheathing, 20% moisture content is often cited as an upper threshold for acceptable performance. The north-facing sheathing moisture contents at the Dunbar-Southlands house exceeded this 20% threshold when the assembly was closed in spring of 2005 and again over the first fully occupied winter (January through April of 2006). In June of 2006 BSCI made a visit to the Dunbar-Southlands house to visually inspect the plywood roof sheathing. Inspection openings were made near locations RNEL, RNWL and RSWL. A 150 mm (6 in.) diameter disk of drywall was cut and the ocSPF insulation was carefully removed to expose the indoor face of the plywood sheathing. Figure 9 shows the inspection opening made at location RNEL. The black dots visible in the right photo are holes from the handheld moisture meter. Handheld meter readings agreed well with the in-situ monitoring system. None of the test cuts showed any signs of mold or decay, the interior surface of the plywood was clean and the material resisted penetration of the moisture meter pins and the point of a pocket knife just as new plywood sheathing would.

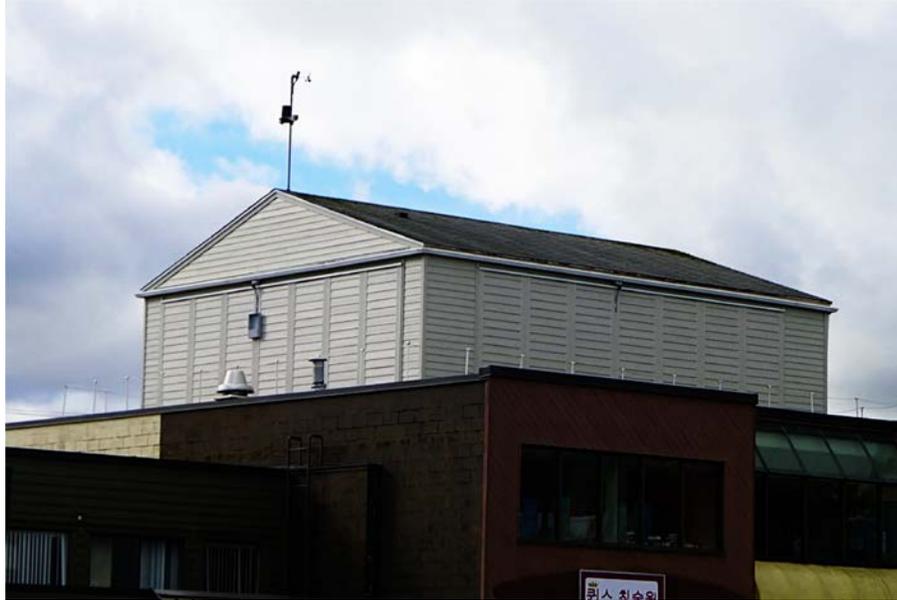
Figure 11 – Coquitlam Test Hut

Since 2005 BSCI staff have operated the Coquitlam Test Hut as a joint project with Gauvin Construction in Coquitlam, BC. This test hut was designed to facilitate field exposure assessment of full-scale roof and wall assemblies in the climate of Vancouver and the Lower Mainland. The structure is located on the rooftop of a three storey commercial building so test walls are exposed to unobstructed weather approach from all directions. The test hut accommodates seven 1.2 x 2.4 m (4 x 8 ft.) test wall assemblies on each of the North, East, South, and West orientations plus three 1.8 x 5.4 m (6 x 18 ft) test attic / roof assemblies, each with North and South-facing roof slopes.

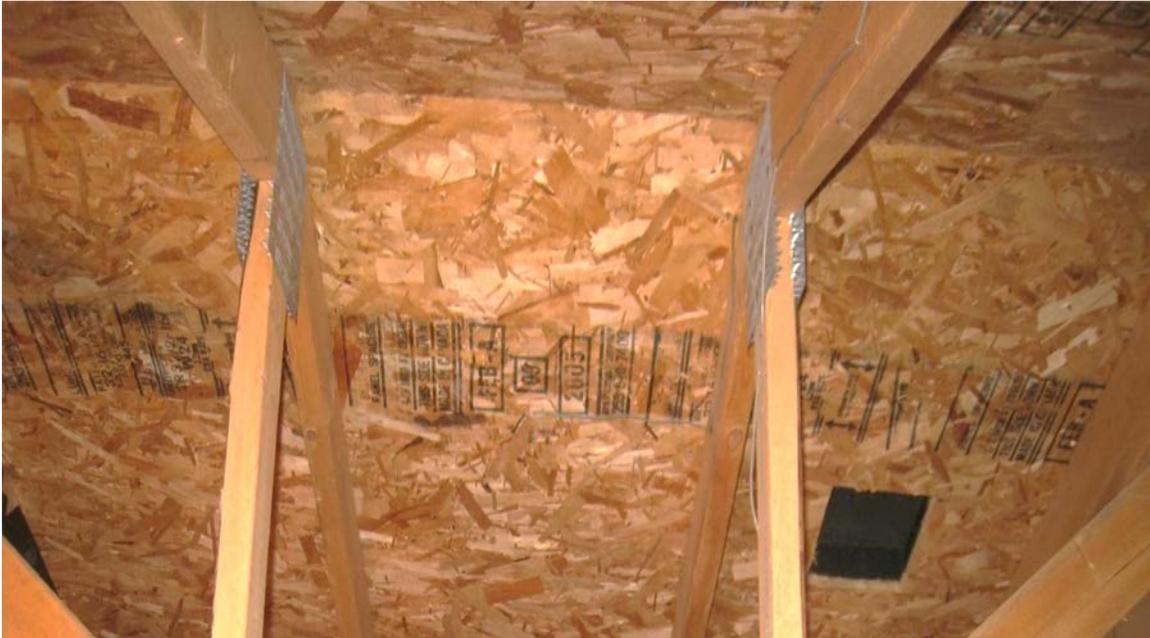
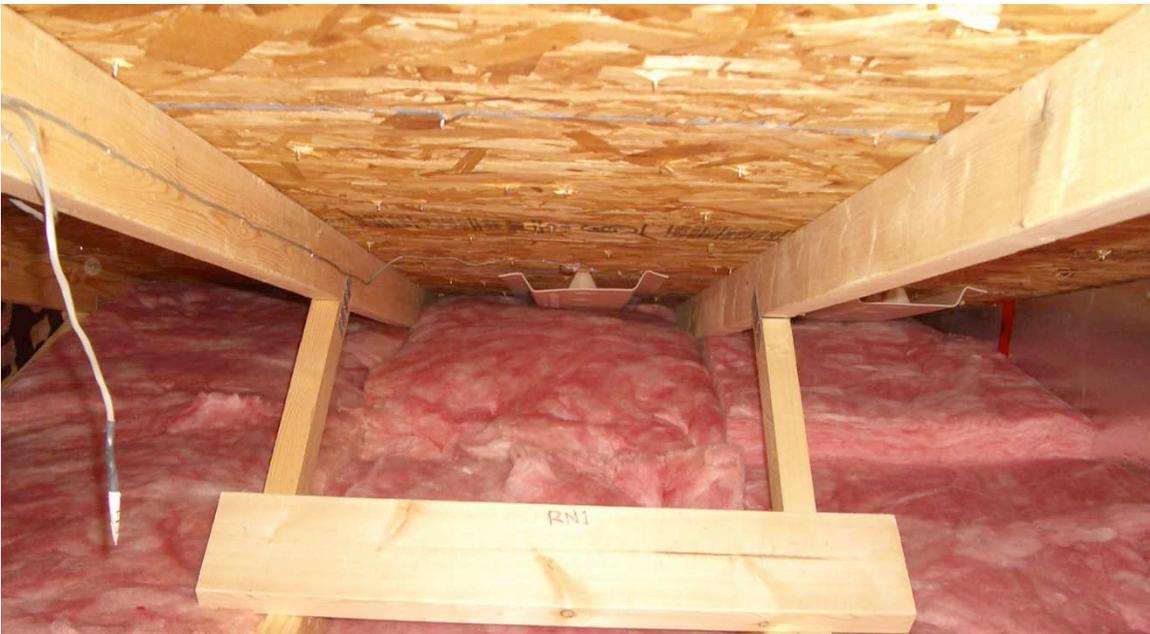
Figure 20 and Figure 21 show the OSB roof sheathing and truss chords on the north-facing slope of Roof 1, the ventilated attic roof assembly in May of 2015. After 9 years of operation and, at the peak of the annual Mold index, still no visible mold was identified on the visible OSB sheathing or the wood framing of the trusses. Protruding roofing nails were noticeably rusty.

Figure 20 – Coquitlam Hut 9 yr Photo –Roof 1, Ventilated Attic – Sheathing at Ridge

Figure 21 – Coquitlam Hut 9 yr Photo – Roof 1, Ventilated Attic – Sheathing at Eave on North-facing Slope

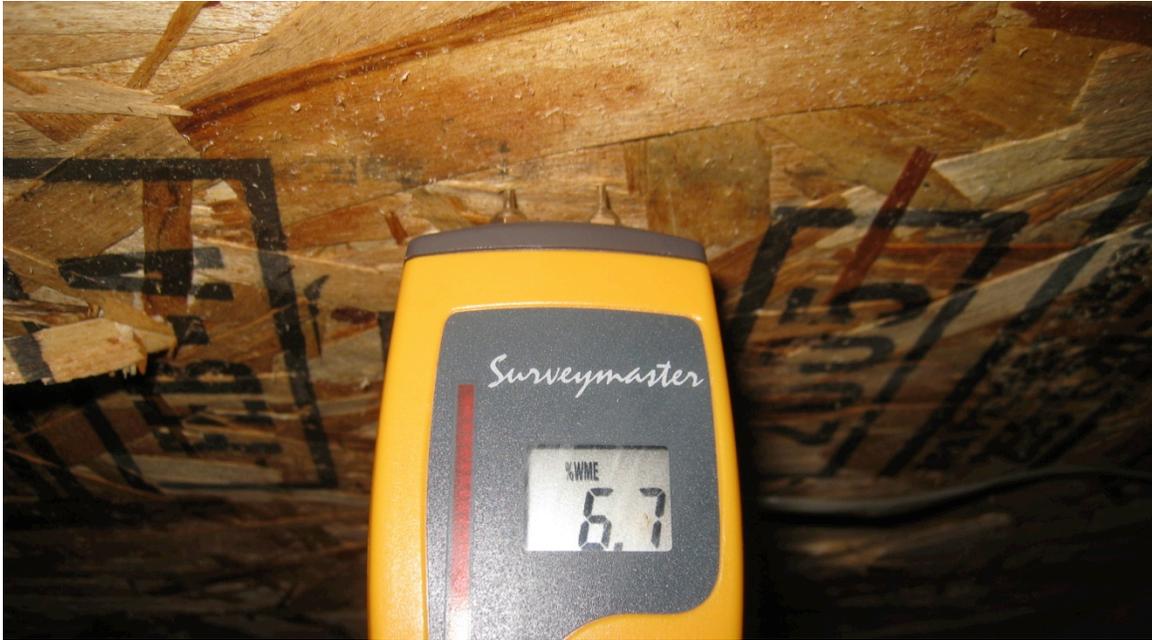
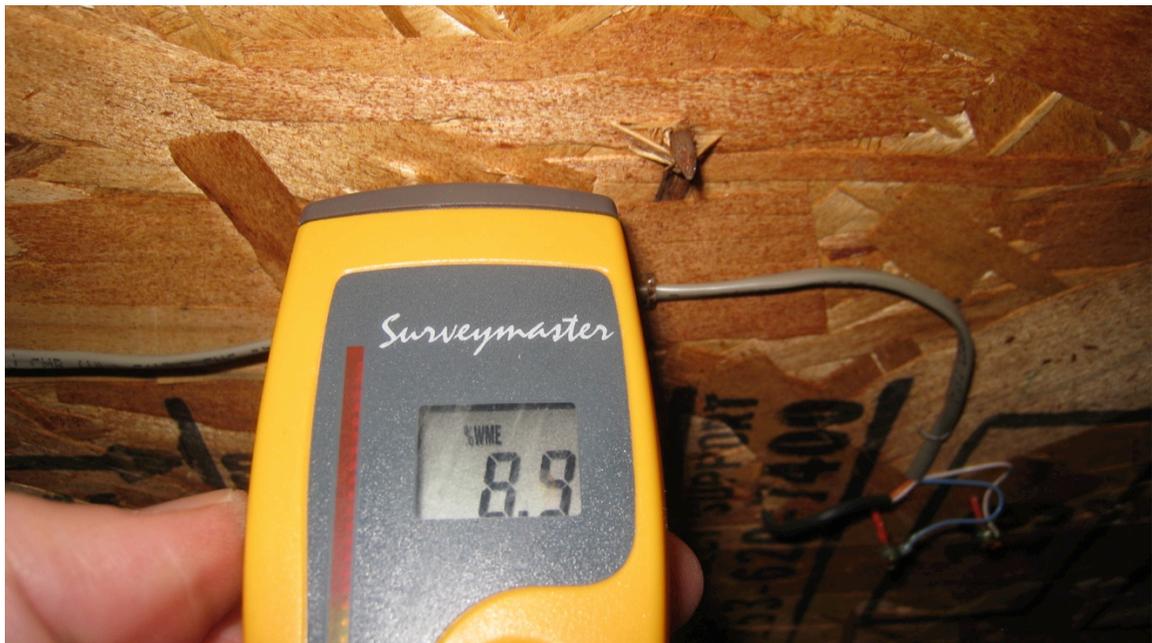
At the time of the investigation the outdoor temperature was roughly 9°C (48°F), the outdoor dewpoint was approximately 7°C (45°F), the attic temperature was 20°C (68°F), and the attic dewpoint was 9.5°C (49°F). The sky was overcast and the roof sheathing temperature was 14-16°C (47-61°F). The sheathing moisture content ranged from 6.5% on the South-facing slope to 9% on the North-facing slope (Figure 22 and Figure 23)

Figure 22 – Coquitlam Hut 9 yr Photo – Roof 1, Ventilated Attic – Sheathing MC on South-facing Slope

Figure 23 – Coquitlam Hut 9 yr Photo – Roof 1, Ventilated Attic – Sheathing MC on North-facing Slope

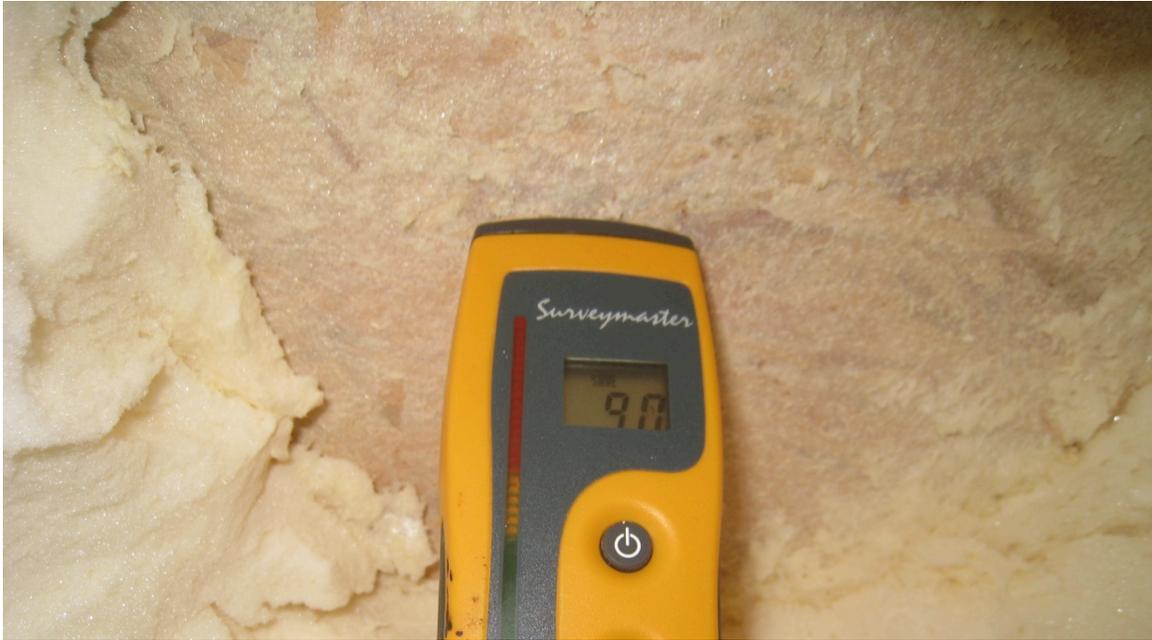
At the time of the investigation the attic temperature in Roof 2 was 22°C (72°F), and the attic dewpoint was 15°C (59°F). Under the overcast sky the roof sheathing temperature was 18-22°C (64-72°F). The sheathing moisture content ranged from 9% on the South-facing slope to 13% on the North-facing slope (Figure 26 and Figure 27).

Figure 26 – Coquitlam Hut 9 yr Photo – Roof 2, ocSPF-Insulated UCA with Latex Paint – Moisture Content on South-facing Slope

Figure 27 – Coquitlam Hut 9 yr Photo – Roof 2, ocSPF-Insulated UCA with Latex Paint – Moisture Content on North-facing Slope

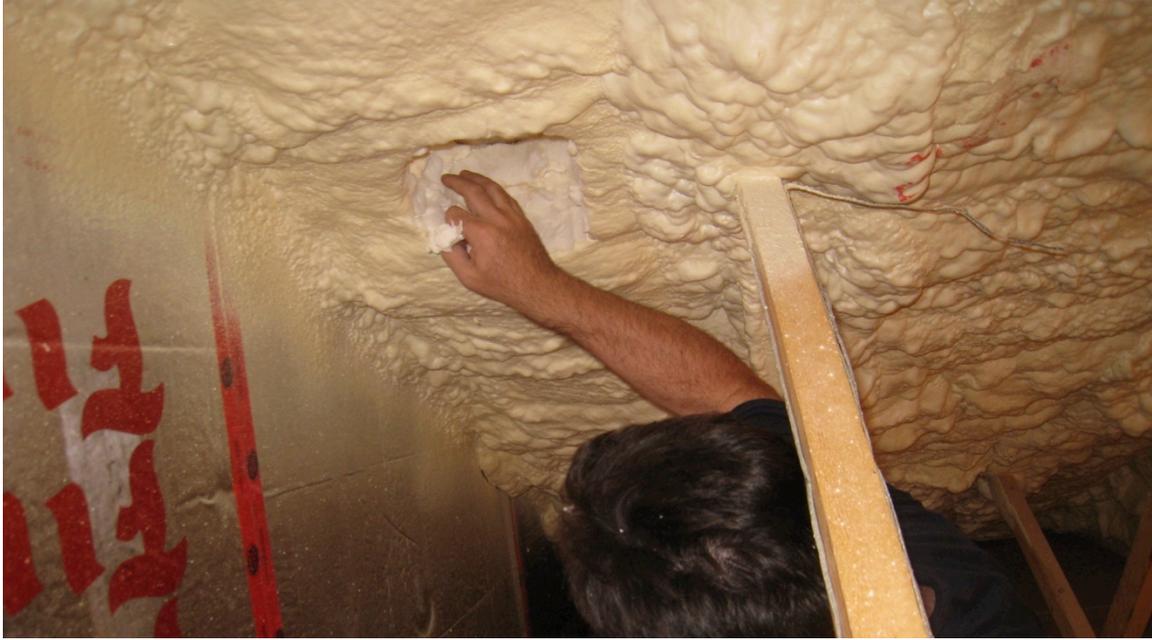
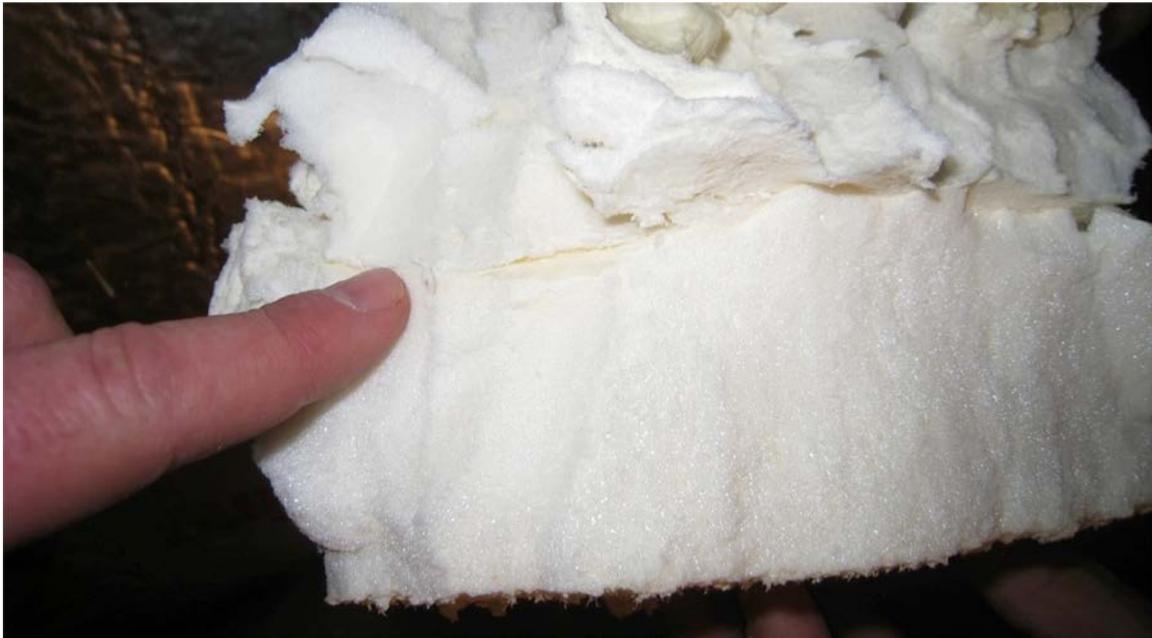
Figure 28 shows an investigator making an investigation opening in the ocSPF on the north-facing slope of Roof 3, the ocSPF-insulated unvented cathedralized attic roof assembly. Figure 29 shows the two lifts of foam that were applied to achieve the 250 mm (10 in.) total thickness. Again the roofing nails were noticeably rusty, but no visible mold was identified OSB sheathing in the inspection openings.

Figure 28 – Coquitlam Hut 9 yr Photo – Roof 3, ocSPF-Insulated UCA without Latex – Creating Inspection Opening

Figure 29 – Coquitlam Hut 9 yr Photo – Roof 3, ocSPF-Insulated UCA without Latex – 2 Lifts of Foam Visible

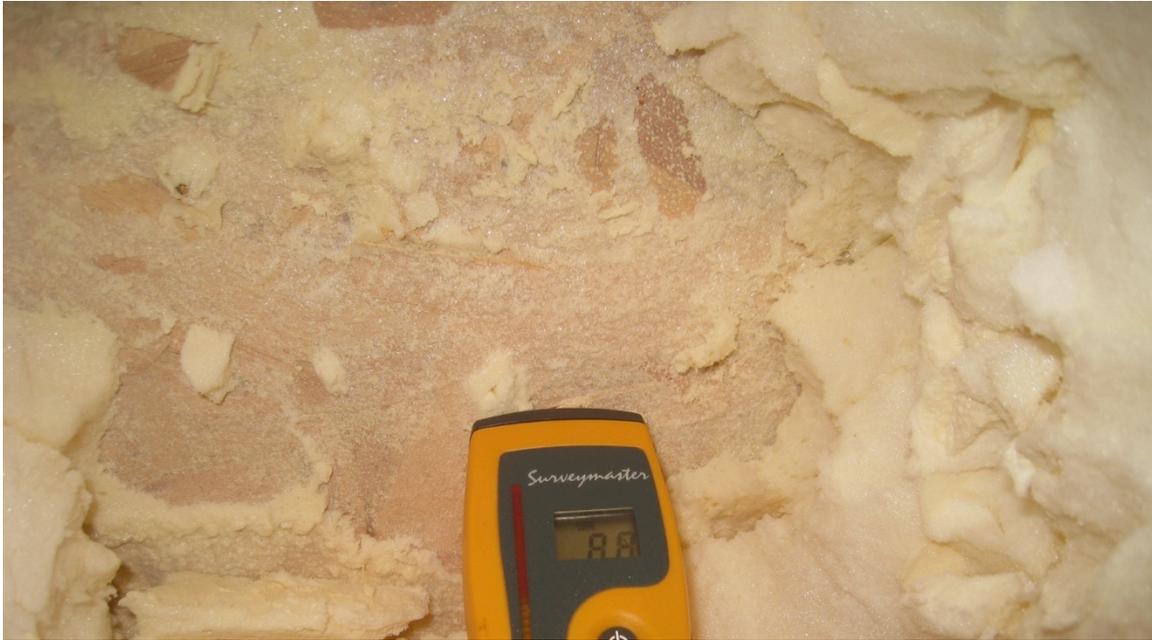
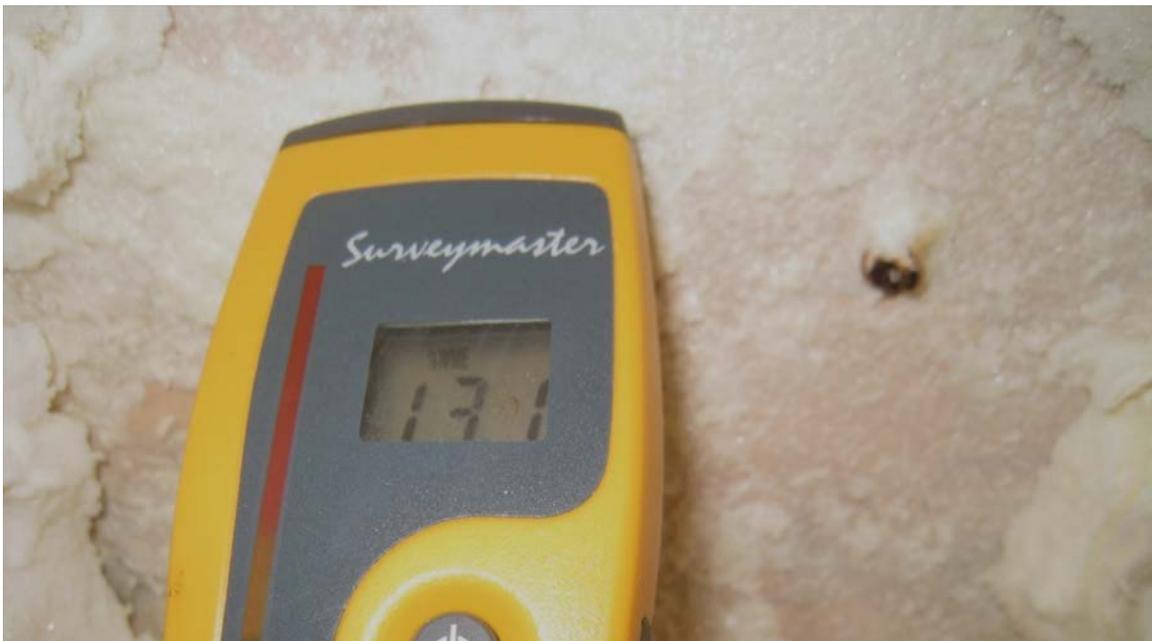
At the time of the investigation the attic temperature in Roof 3 was also around 22°C (72°F). The attic dewpoint was 16°C (61°F). Under the overcast sky the roof sheathing temperature was 18-21°C (64-70°F). The sheathing moisture content ranged from just under 9% on the South-facing slope to a little over 13% on the North-facing slope (Figure 30 and Figure 31).

Figure 30 – Coquitlam Hut 9 yr Photo – Roof 3, ocSPF-Insulated UCA without Latex – Moisture Content on South-facing Slope

Figure 31 – Coquitlam Hut 9 yr Photo – Roof 3, ocSPF-Insulated UCA without Latex – Moisture Content on North-facing Slope

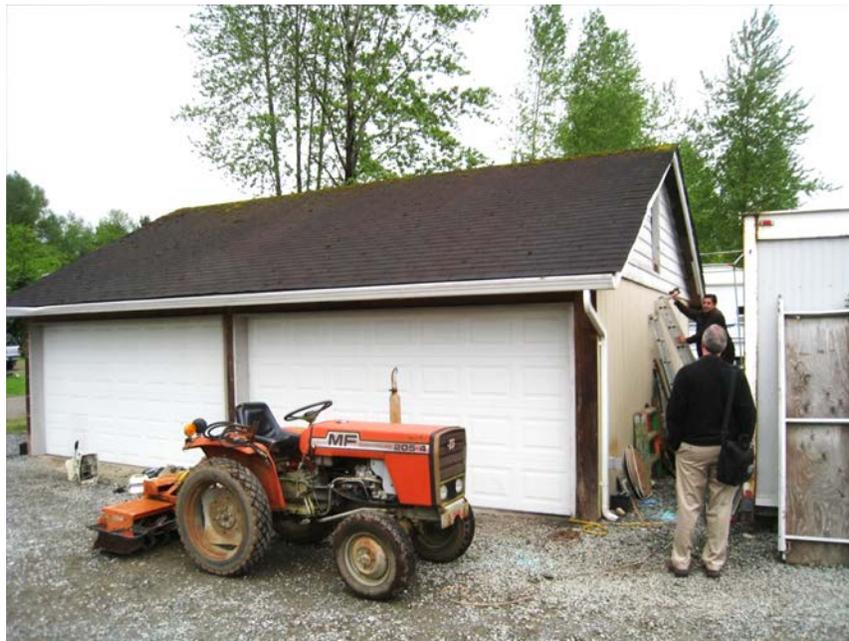
Figure 32 – Langley Workshop

The Langley Workshop serves as an equipment and tool repair and maintenance shop for a local contractor. Figure 32 shows the workshop from the front. The building is decades old and the age of the wood is evident in its dark colour. Roughly 5 years ago ocSPF insulation applied to create a cathedralized unvented attic. The resulting roof assembly doesn't include any vapour control layers to limit outward diffusion during cold weather.

Large openings exist in the ceiling so the air in the attic has the same properties as the air in the workshop below. Furthermore, the building appears to be very leaky so it should be expected to track outdoor dewpoint conditions. However, there are significant sources of indoor moisture associated with some of the processes employed in the workshop.

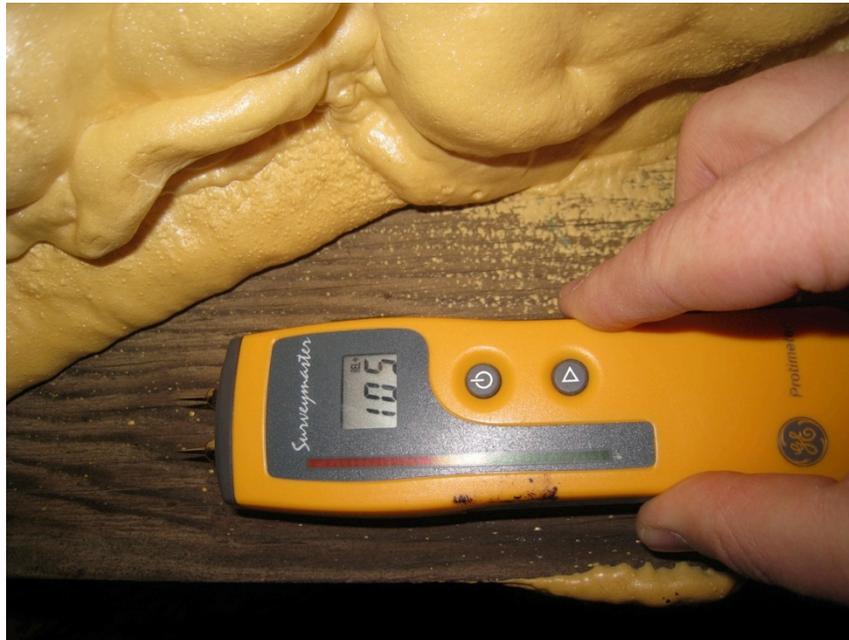
Figure 33 – Langley Workshop – Moisture Content of Exposed Wood Framing

On the morning of the visit the temperature in the attic was roughly 15°C (59°F) and the relative humidity was 50% so the dewpoint equal to outdoor dewpoint. The exposed wood framing elements (collar ties) registered moisture content of 10.5%.

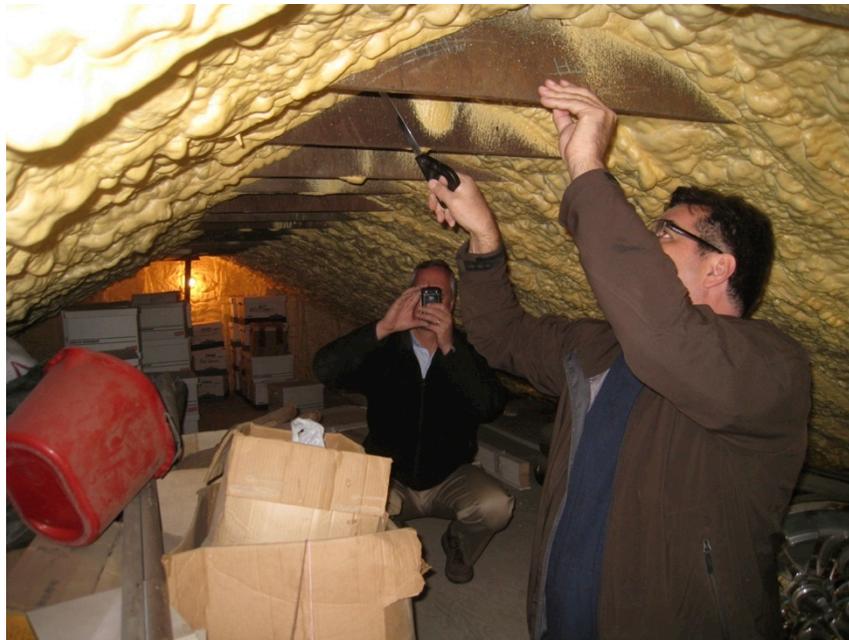
Figure 34 – Langley Workshop – Cutting an Investigation Opening in the ocSPF

Inspection openings were made at two locations on the north-facing slope and two locations on the south facing slope (Figure 34). No visible mold were observed on the exposed plywood sheathing (Figure 35). However, the plywood sheathing was dark with age in a manner similar to the wood framing. On the north-facing slope the moisture content of the sheathing was around 12% while it was just under 7% on the south-facing slope (Figure 36 and Figure 37).

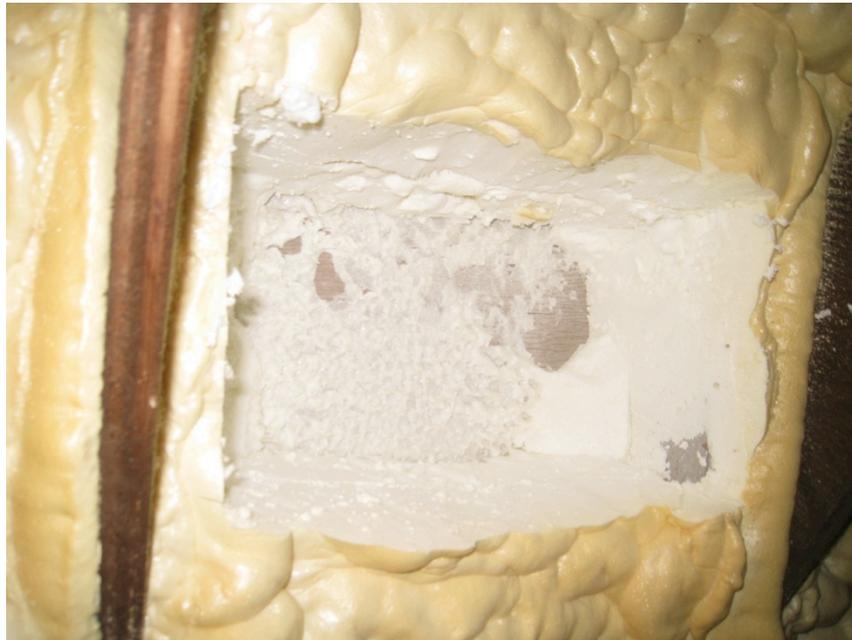
Figure 35 – Langley Workshop – Investigation Opening on North-facing Slope

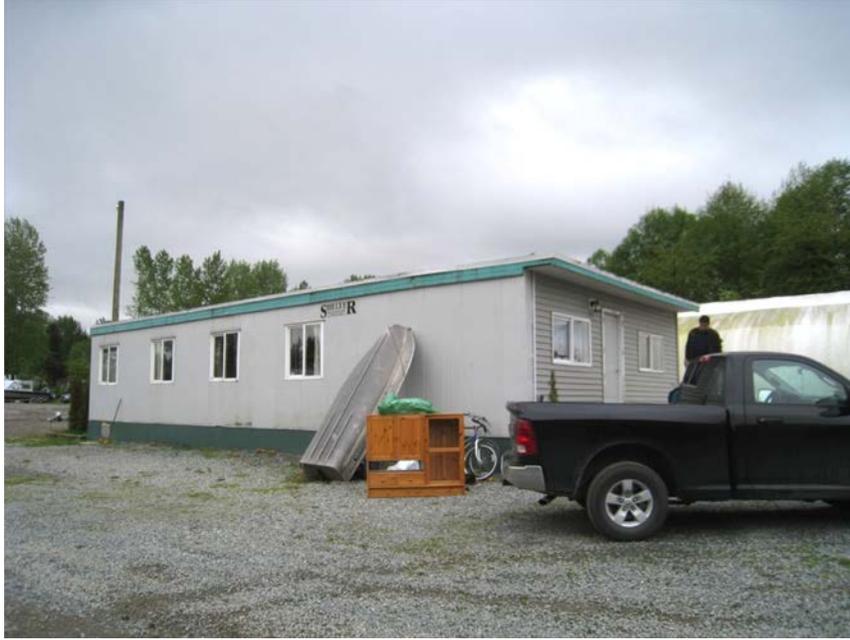
The Langley Trailer Home was renovated approximately 3 years ago (Figure 38 and Figure 39). The walls and roof of the structure were insulated with 100-200 mm (4-6 in.) of ocSPF insulation. The roof assembly has a very low slope so the renovation produced a very flat ocSPF-insulated cathedral ceiling roof assembly. The roof assembly does not include a polyethylene vapour barrier however, the painted GWB ceiling may provide some control of outward vapour diffusion during cold weather.

Figure 38 – Langley Trailer Home – Outside View

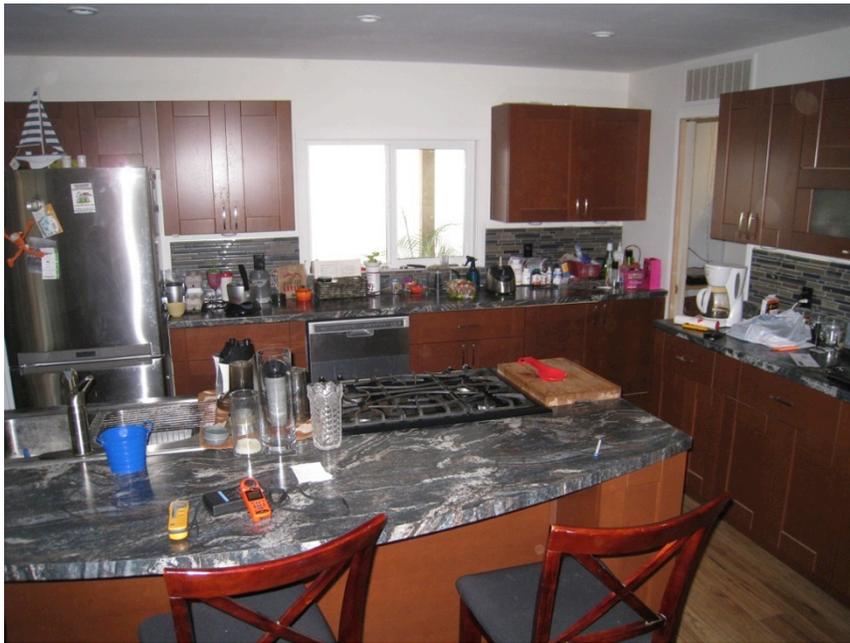
The renovation resulted in a very airtight structure that was without an operating ventilation system. Everyone noted the feeling of high humidity on entering the building. The indoor temperature was almost 19°C (68°F) and the relative humidity was almost 70% so the indoor dewpoint was over 13°C (54°F), well above recommended levels for early spring (Figure 40).

Figure 39 – Langley Trailer Home – Renovated Kitchen

While we did not note any visible signs of mold, we strongly recommend against operating with an indoor RH of 70% in the climate of Vancouver and the Lower Mainland. In this climate ventilation systems should be designed, installed and operated to maintain wintertime indoor humidity below 40% RH.

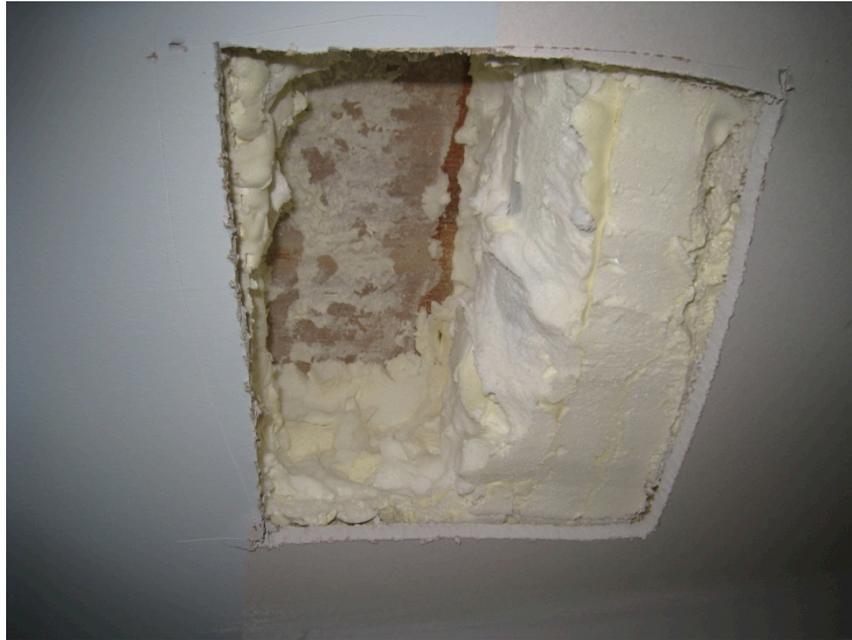
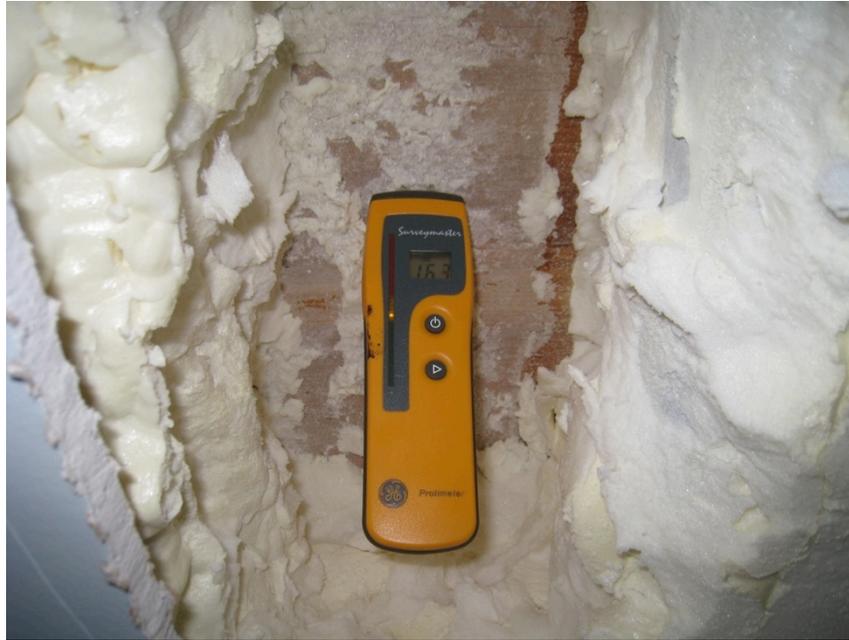
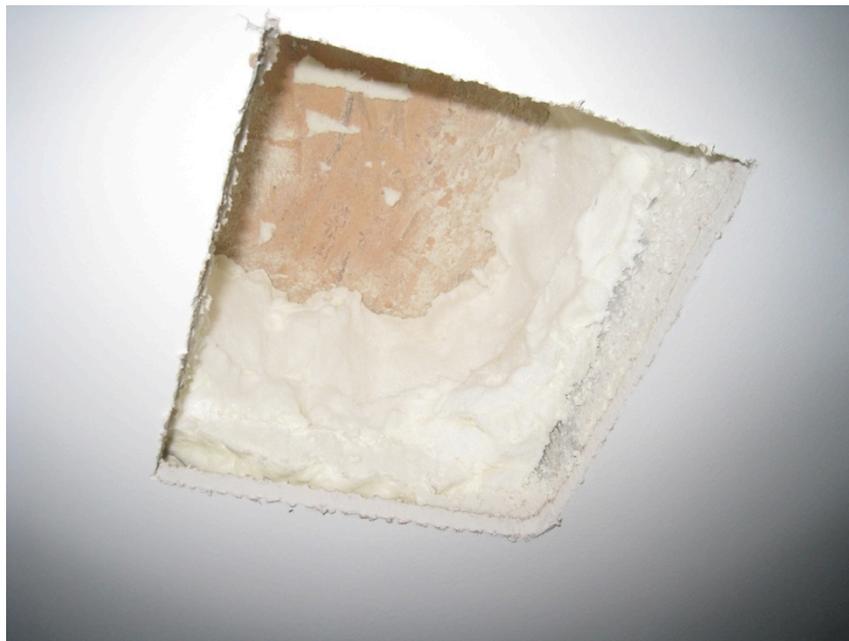
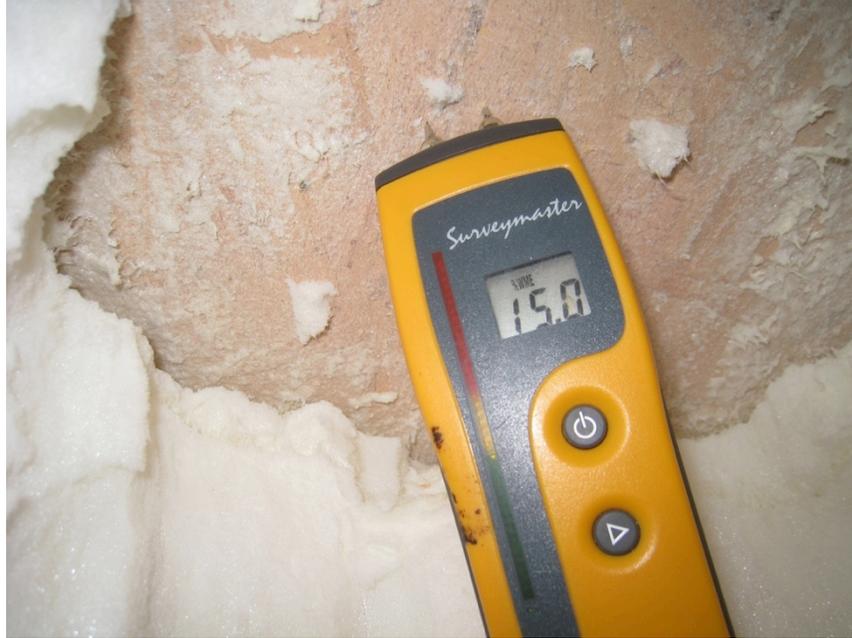
Two inspection openings were made: the first in the utility room off the kitchen and a second in the bedroom at the other side of the house. The surface of the plywood sheathing felt damp but there was no visible mold in either of the inspection openings. Sheathing moisture contents of 16.3 and 15% were measured in the two inspection openings.

Figure 41 – Langley Trailer Home – Inspection Opening 1 – Utility Room

Figure 42 – Langley Trailer Home – Inspection Opening 1 – Sheathing Moisture Content

Figure 43 – Langley Trailer Home – Inspection Opening 2 – Bedroom

Figure 44 – Langley Trailer Home – Inspection Opening 2 – Sheathing Moisture Content

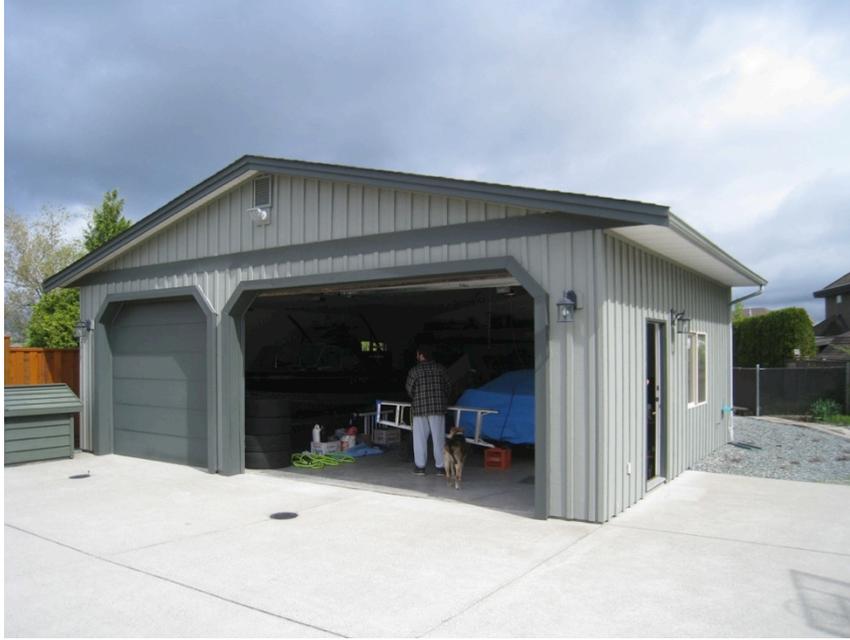
Figure 45 – Langley Hobby Garage – Outside View

The Langley Hobby Garage had a much more reasonable indoor dewpoint than the Trailer Home. The indoor temperature was 16.5°C (62°F) and the relative humidity was approximately 50% so there was a 6°C (43°F) dewpoint in the Hobby Garage.

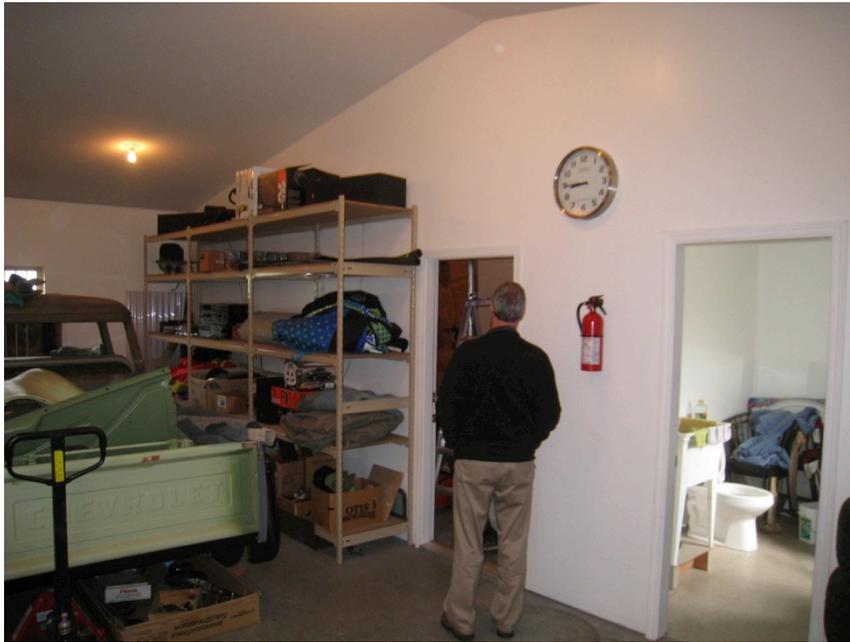
Figure 46 – Langley Hobby Garage – Inside View

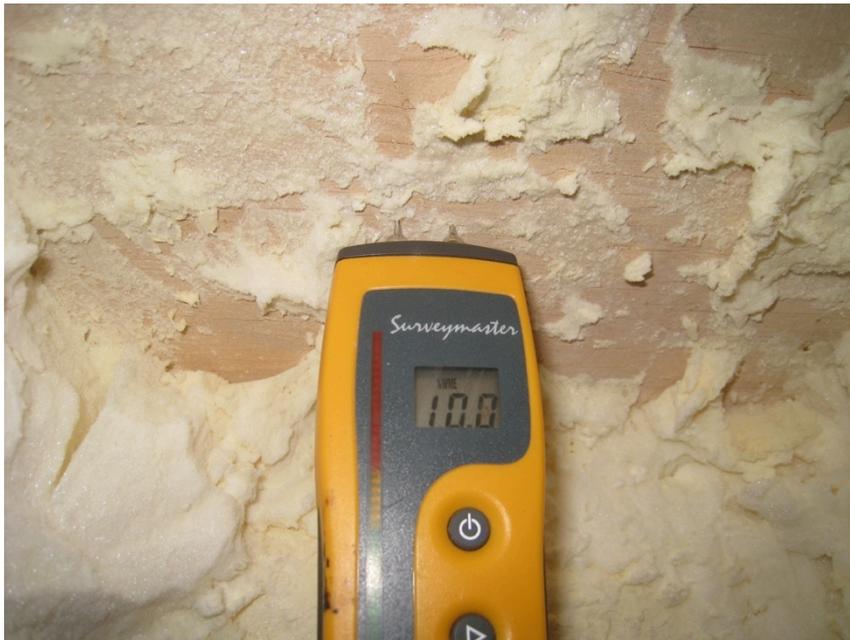
Figure 48 – Langley Hobby Garage – Moisture Content of Plywood Roof Sheathing

A moisture content of 10% was measured in the plywood roof sheathing near the ridge.
